**MOTOR BRAKE SERVICE**

**Reference:** Razor Motor brakes on Razor drives

**Product affected:** All versions of the Razor Motor Brakes

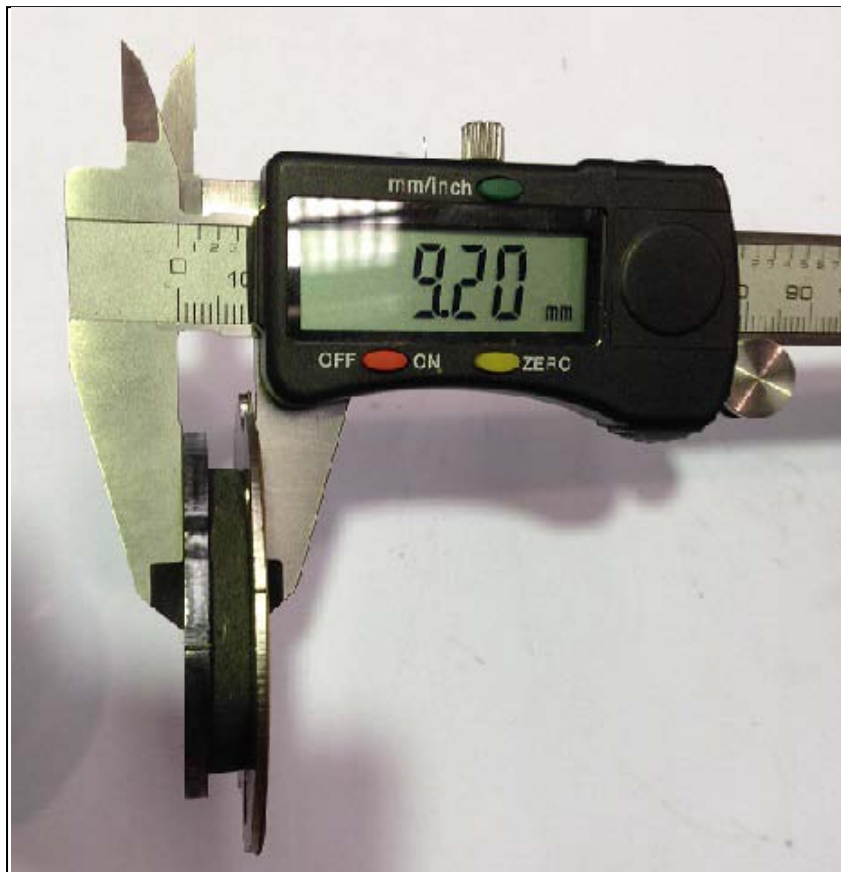
**Symptom:** With ongoing use the brake pad will wear and if it is found that it is not holding, then it will probably need to be shimmed by adding a 0.26mm brake shim( Note: The combined working thickness for the brake back plate, the brake pad and the brake plate should not be less then 9.15mm and not greater than 9.28mm).Refer image below.
